**Flood Control Project Maintenance  
Levee Inspections**

**Fall 2016 Levee Maintenance Deficiency Summary Report**

**Reclamation District No. 0787 Fair**

Waterway			Bank	Unit Miles
Unit No. 01 Colusa Basin Drain			Left	4.45
	Spring (March - May)	Summer (June - August)	(September - November) Fall	Winter (December - February)
Unit Maintenance Rating (Fall Only)			<b>A</b>	
Date of Inspection	3/22/2016 - 3/22/2016		9/26/2016 - 9/26/2016	
DWR Inspector	Jai Lor		Oleg Yakimov	
Accompanied By	Roger Cornwell Rivergarden Farms RD 787		Roger Cornwell Rivergarden Farms RD 787

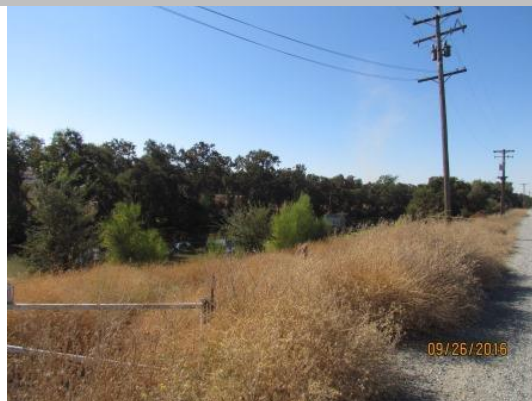
Photo 1 of 1 : FA\_2016\_RD0787\_212\_4\_20160926\_00013.jpg

LM Start	0.01	Rating **	M	Issue No.	4
LM End	0.02	Issue Type +	Ma	Location *	WS
Category	Earthen Levee			GPS Latitude/Longitude	
				Start	End
Item	Vegetation			38.799508 °	38.799464 °
				-121.725522 °	-121.725564 °
DWR ID	DWR_RD0787_01_f_2016_4				
Comment Code					
V2 : Remove the wild growth other than native grasses from the levee slopes.					
Inspector Comment

Vegetation on waterward slope. Fall 2016.

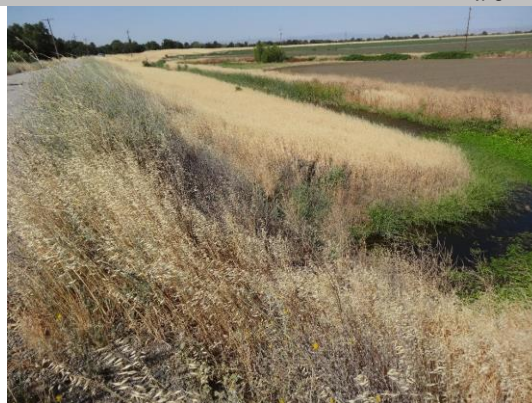
Photo 1 of 2 : UCIP\_FA\_2016\_37585\_68154.jpg

Comment Code					
Inspector Comment					
FS_ID:37585					
DS_ID:22892					
EP_NO: 9392					
Repair Type: Non-Urgent					
Crossing Status: Found					
UCIP Comments: Dense vegetation limits the inspector's visibility to identify signs of pipe failure (leaks) along the slope. Recommend removing vegetation along pipe alignment to conduct proper inspection of structure.					
FIELD_STRUCT_DESC: 36-inch concrete pipe through the levee 17.0 feet below the crown. Slide gate in 36-inch standpipe on the waterward side (App. 9392 - River Garden Farms). 24-inch pipe from standpipe to pump house mounted on steel structure in channel. Pump and 24-inch steel pipe installed on the waterward side, 1962 (App. 3878 - river Garden Farms).					
FS Date: 6/10/2014

View of landward slope.

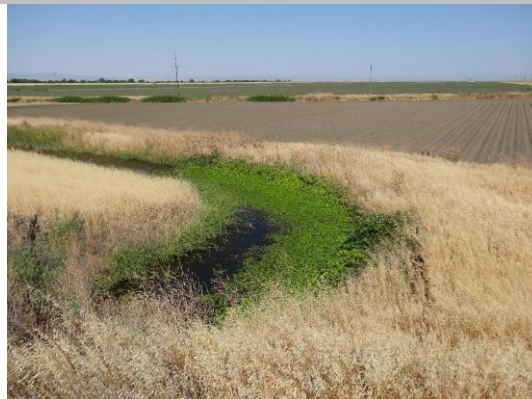
Photo 2 of 2 : UCIP\_FA\_2016\_37585\_68153.jpg

Comment Code						
Inspector Comment						
FS_ID:37585						
DS_ID:22892						
EP_NO: 9392						
Repair Type: Non-Urgent						
Crossing Status: Found						
UCIP Comments: Dense vegetation limits the inspector's visibility to identify signs of pipe failure (leaks) along the slope. Recommend removing vegetation along pipe alignment to conduct proper inspection of structure.						
FIELD_STRUCT_DESC: 36-inch concrete pipe through the levee 17.0 feet below the crown. Slide gate in 36-inch standpipe on the waterward side (App. 9392 - River Garden Farms). 24-inch pipe from standpipe to pump house mounted on steel structure in channel. Pump and 24-inch steel pipe installed on the waterward side, 1962 (App. 3878 - river Garden Farms).						
FS Date: 6/10/2014

View of landward side.

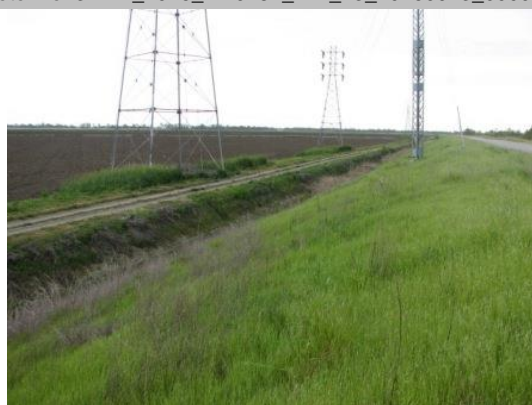
Photo 1 of 3 : FA\_2016\_RD0787\_212\_13\_20160913\_00003.jpg

LM Start	1.58	Rating **	M	Issue No.	13
LM End	2.73	Issue Type +	En	Location *	LS
Category	Earthen Levee			GPS Latitude/Longitude	
				Start	End
Item	Encroachments			38.801794 °	38.809506 °
				-121.750204 °	-121.768979 °
DWR ID	DWR_RD0787_01_s_2012_13				
Comment Code					
DT : Ditch					
Inspector Comment

Agricultural ditch runs along landside the distance of the district.

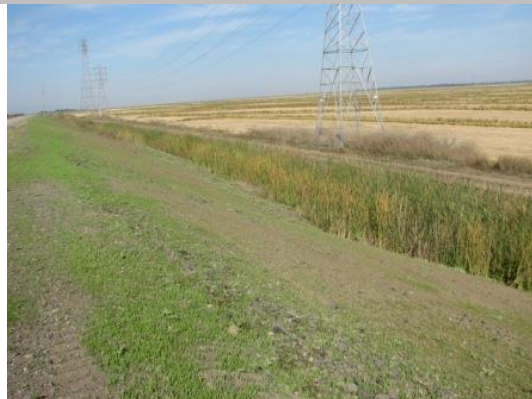
Photo 2 of 3 : FA\_2016\_RD0787\_212\_13\_20160913\_00004.jpg

A view of the agricultural ditch in the fall of 2011.

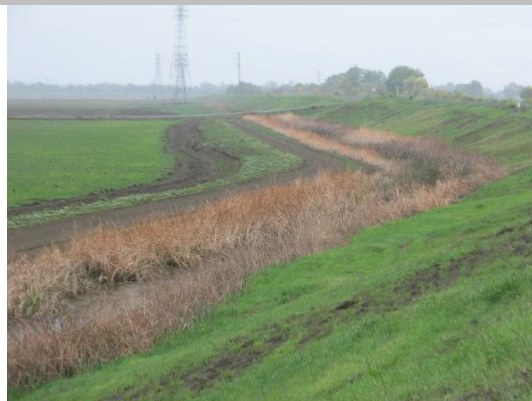
Photo 3 of 3 : FA\_2016\_RD0787\_212\_13\_20160913\_00005.jpg

The agricultural ditch runs along the toe of the levee. Spring 2014

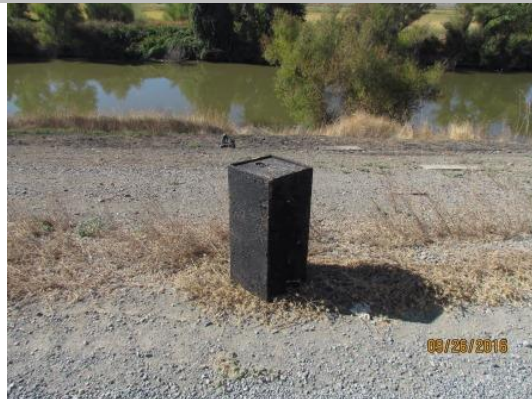
Photo 1 of 1 : FA\_2016\_RD0787\_212\_11\_20160926\_00012.jpg

LM Start	1.73	Rating **	M	Issue No.	11
LM End	1.73	Issue Type +	Ma	Location *	WS
Category	Earthen Levee			GPS Latitude/Longitude	
				Start	End
Item	Encroachments			38.802693 °	38.802693 °
				-121.752672 °	-121.752672 °
DWR ID	DWR_RD0787_01_f_2016_11				
Comment Code					
GA : Garbage					
Inspector Comment

Burnt loudspeaker near levee crown on waterward side. Fall 2016.

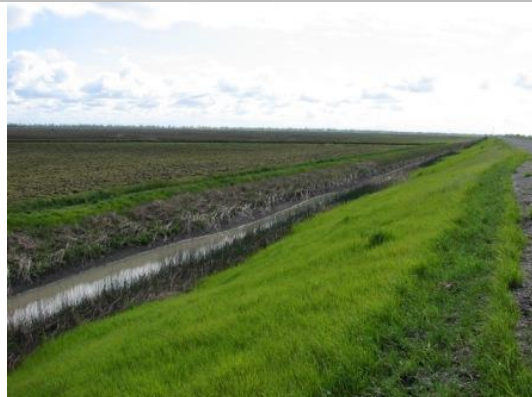
Photo 1 of 3 : FA\_2016\_RD0787\_212\_14\_20160913\_00006.jpg

LM Start	3.13	Rating **	M	Issue No.	14
LM End	4.40	Issue Type +	En	Location *	LS
Category	Earthen Levee			GPS Latitude/Longitude	
				Start	End
Item	Encroachments			38.812963 °	38.822302 °
				-121.774880 °	-121.795295 °
DWR ID	DWR_RD0787_01_s_2012_14				
Comment Code					
DT : Ditch					
Inspector Comment

Ditch along landside toe.

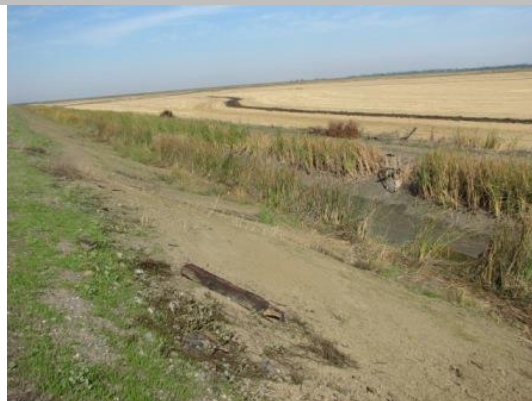
Photo 2 of 3 : FA\_2016\_RD0787\_212\_14\_20160913\_00007.jpg

A current view of the agricultural ditch photo taken in fall of 2011.

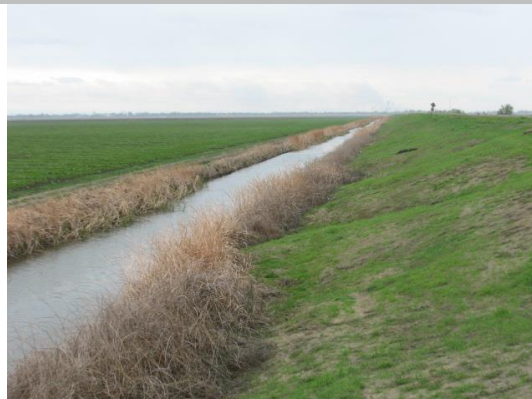
Photo 3 of 3 : FA\_2016\_RD0787\_212\_14\_20160913\_00008.jpg

The agricultural ditch runs along the toe of the levee slope. Spring 2014
